**THE RESPONSE OF SEISMICALLY-ISOLATED HOSPITALS  
IN THE  
KAHRAMANMARAS EARTHQUAKES OF FEBRUARY 6, 2023**

**AN OBSERVATION REPORT**

**TURKISH ASSOCIATION FOR SEISMIC ISOLATION / TASI  
(Deprem İzolasyon Derneđi / DID )**

**May 10, 2023**

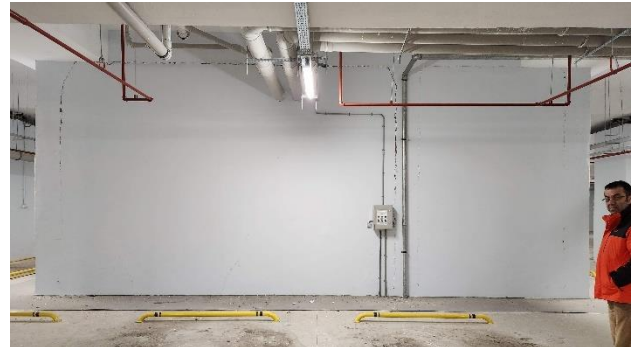
General view of isolation basement

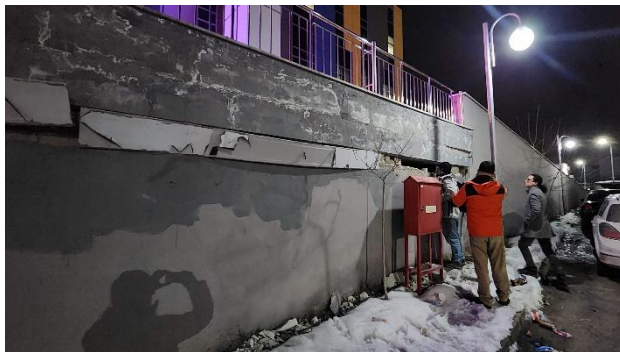
Damage at perimeter joint

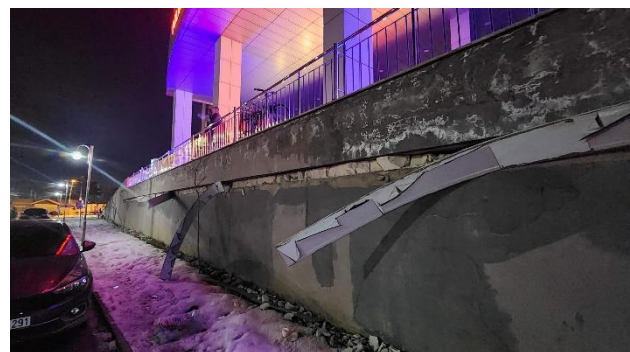
Damage at perimeter joint

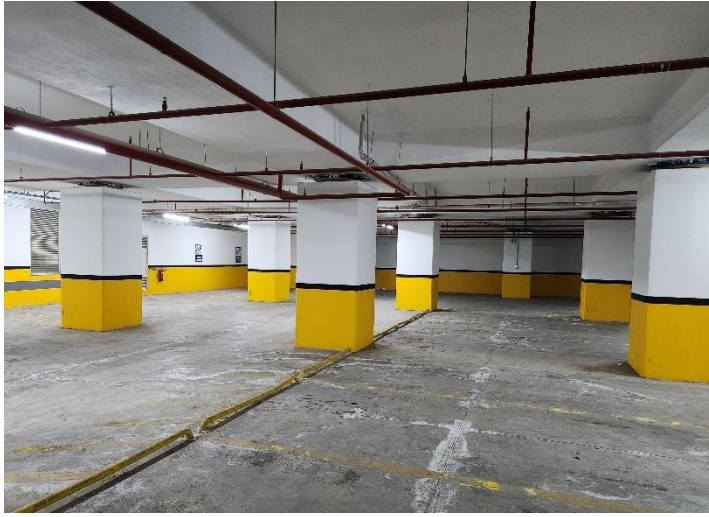
General view of isolation basement

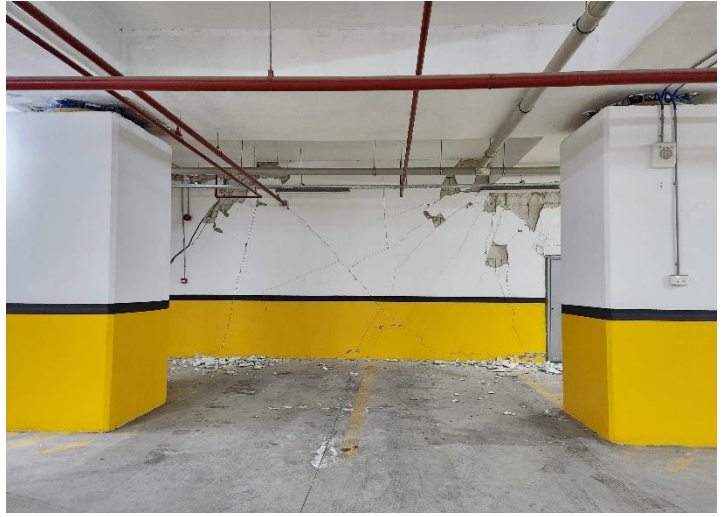
Basement wall damage due to lack of movement joint

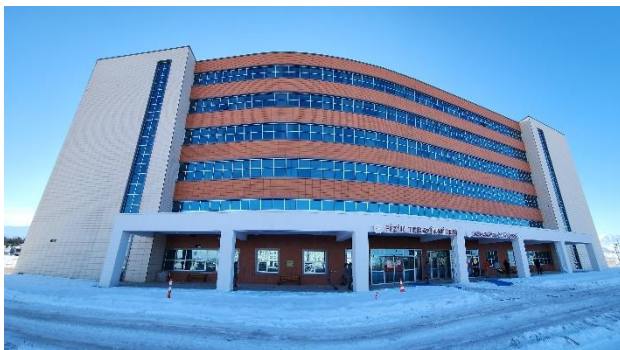
General view of hospital at time of post-earthquake inspection visit

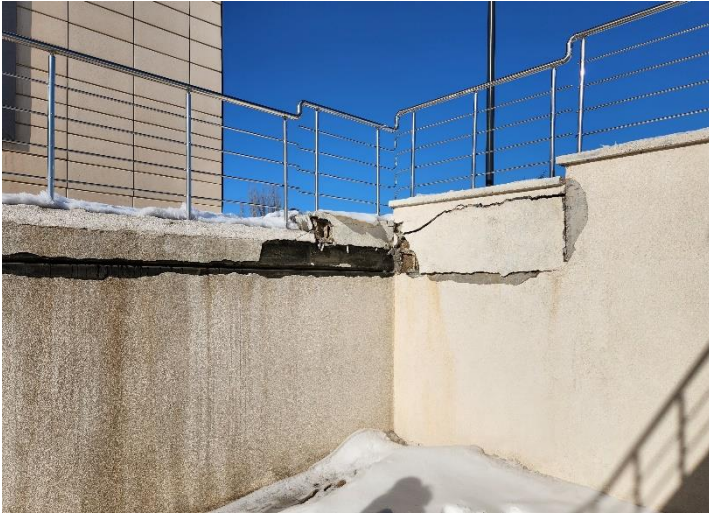
Damage due to no movement clearance between isolated structure and retaining wall

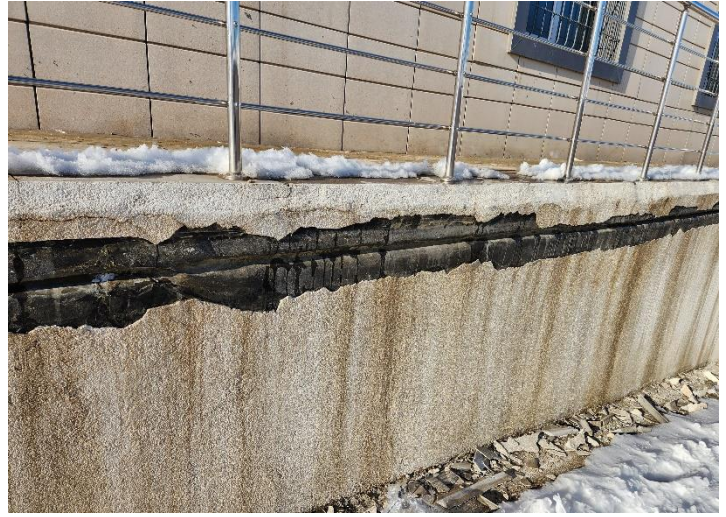
Spalling of plaster at perimeter joint

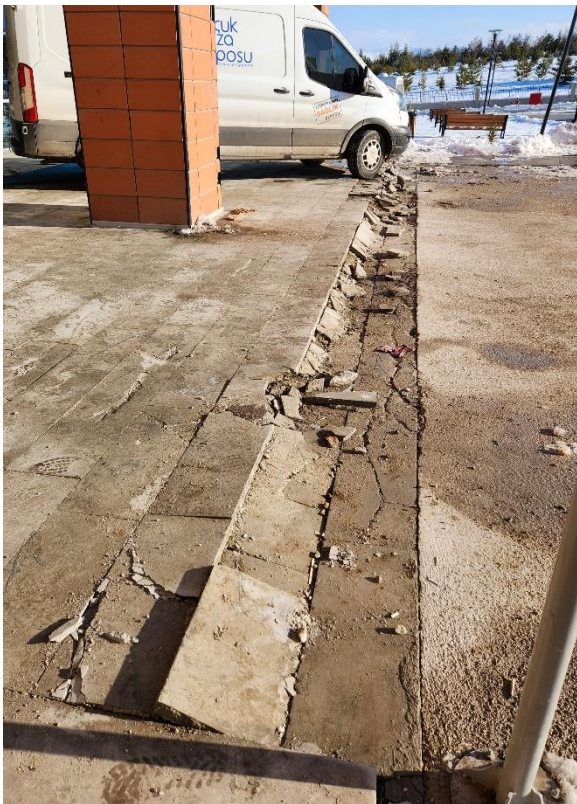
Damage to tilework at moat perimeter

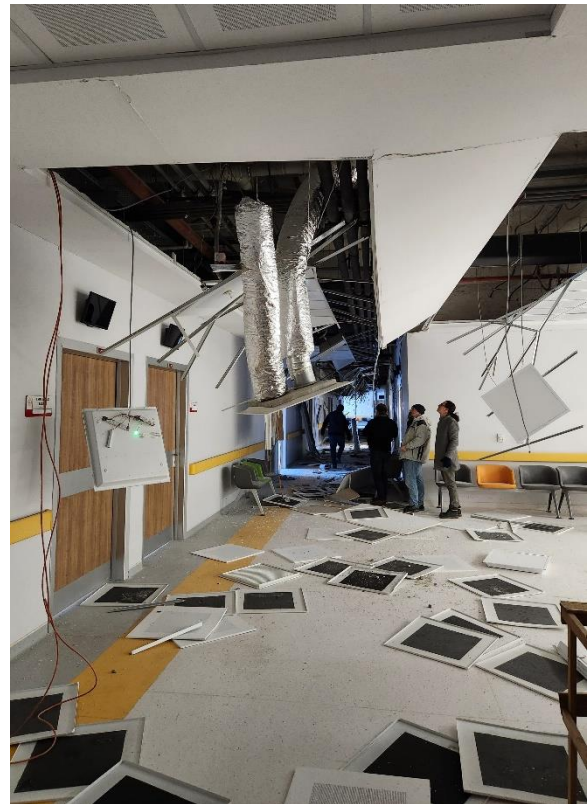
Suspended ceiling damage

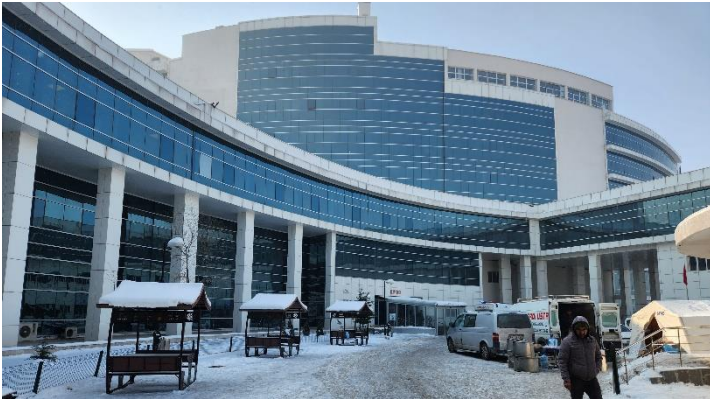
General view of hospital at time of post-earthquake inspection

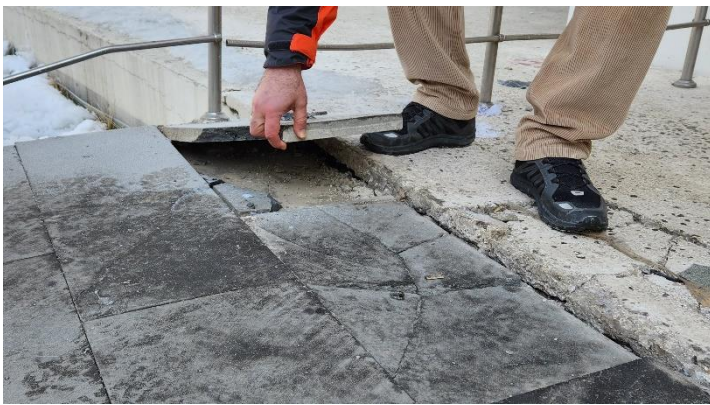
Damage to tile at entryway movement joint

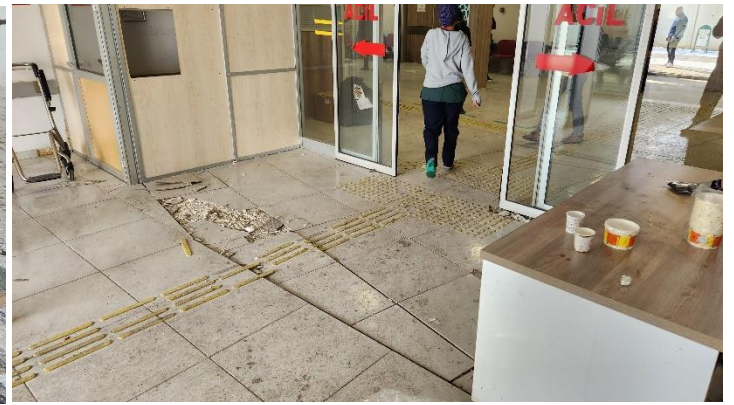
Damage to floor tile at emergency entrance

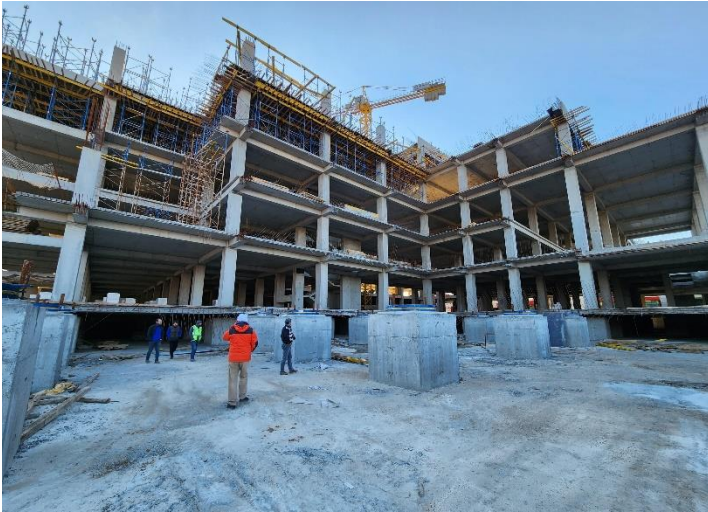
State of construction at time of earthquakes

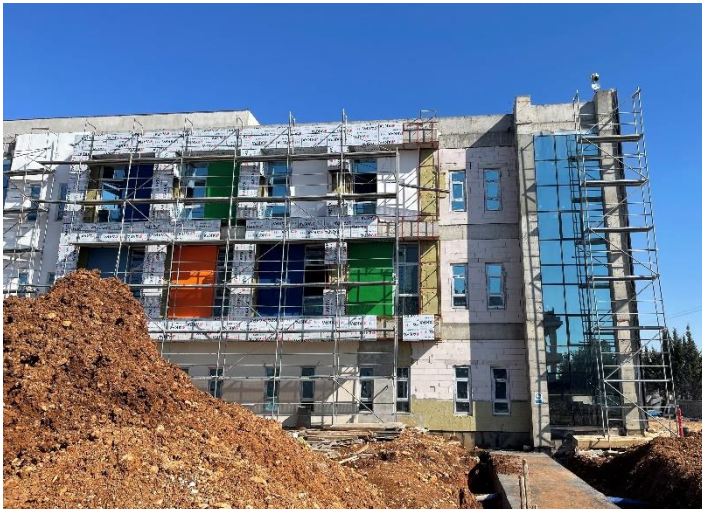
State of construction at time of earthquakes

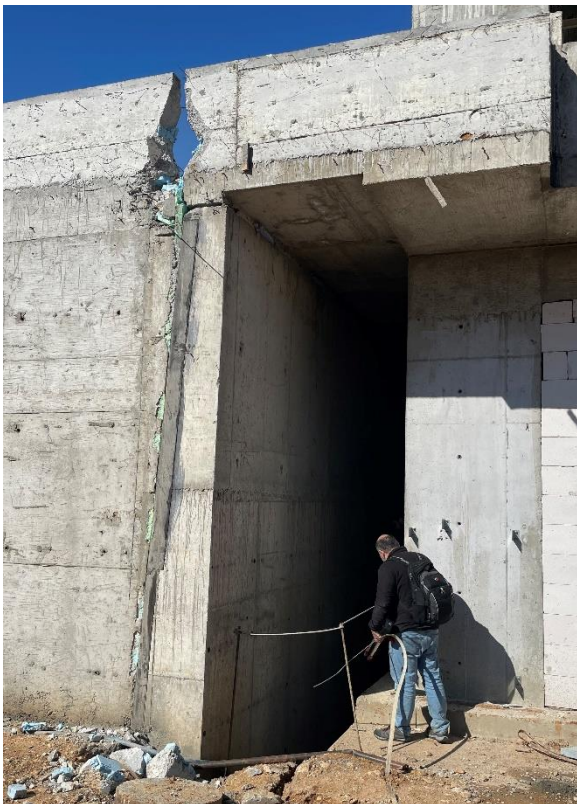
Damage at movement joint with inadequate clearance

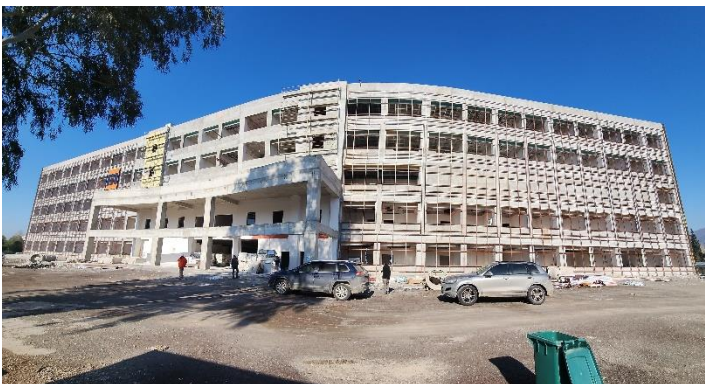
Status of construction at time of earthquake

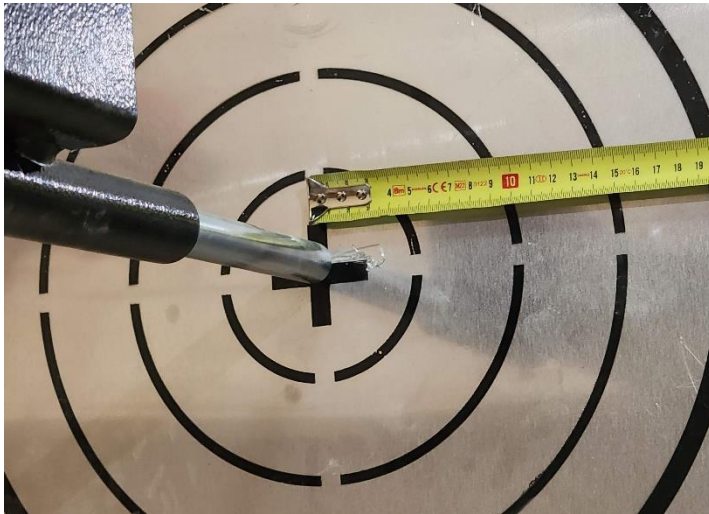
Scratch plate indicating approx. 4 cm maximum movement

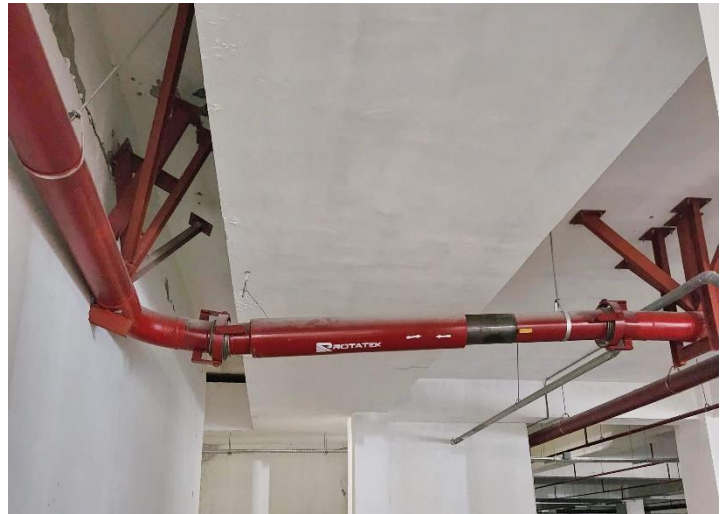
Damage to piping system support due to incorrect function of flexible joint

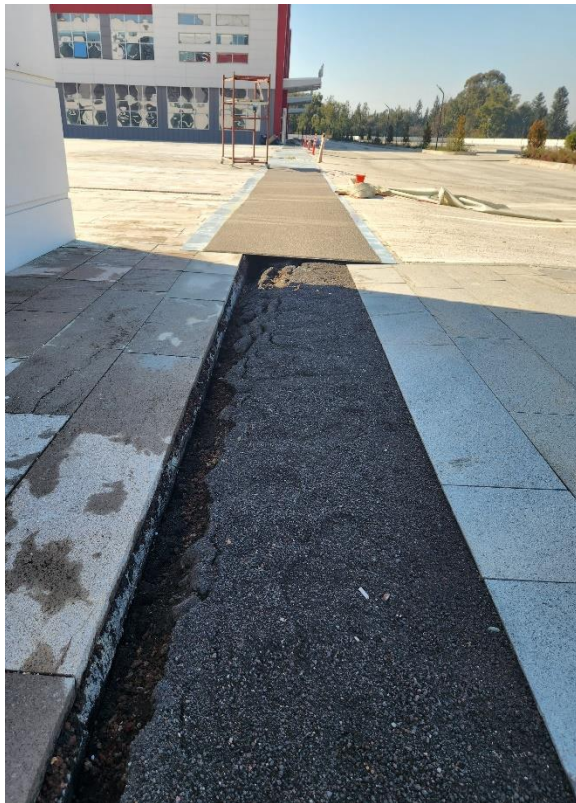
Moat filled with crushed pumice stone and signs of movement

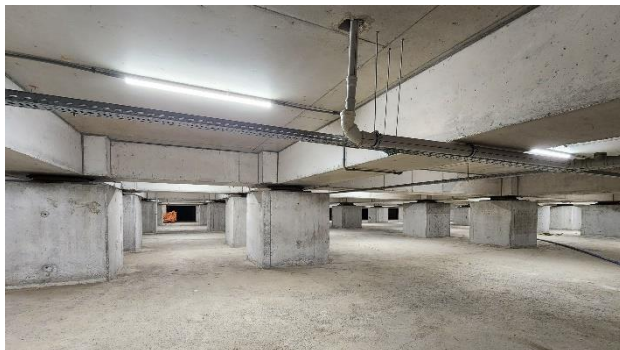
General view of isolation basement

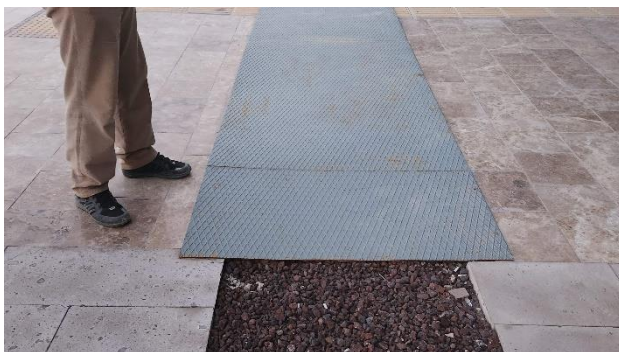
Movement joint at front entrance and crushed pumice stone used as moat infill

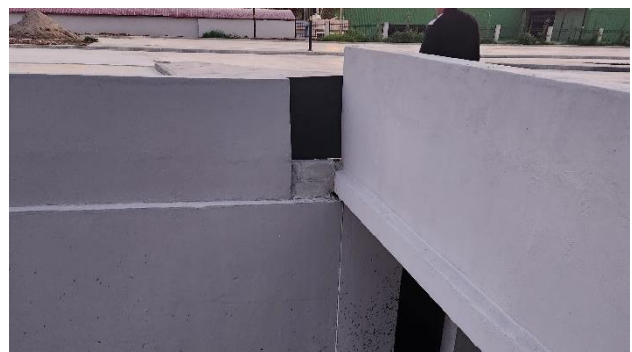
Inadequate movement clearance at pedestrian walkway

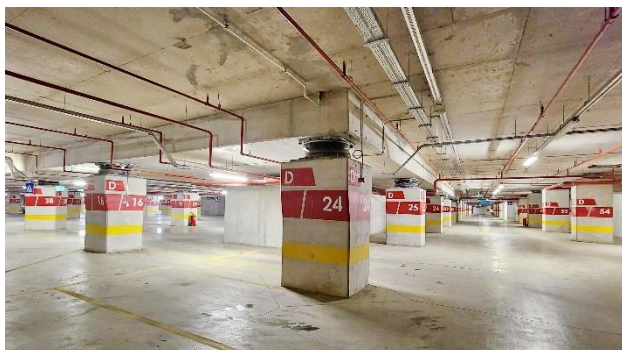
General view of isolation basement

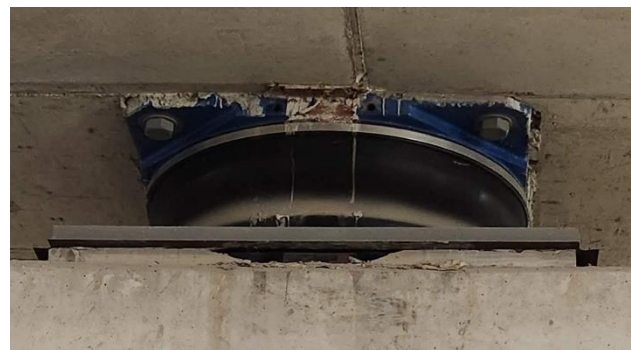
Grout cracking under isolator base plate

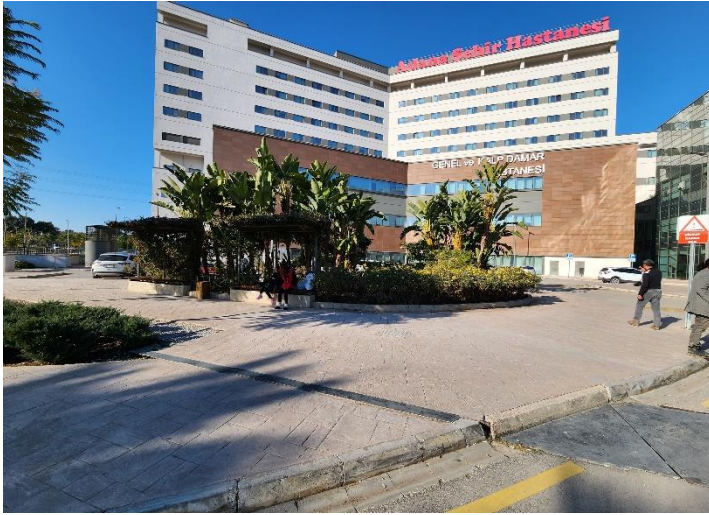
General view of hospital and seismic joint in foreground
