**THE RESPONSE OF SEISMICALLY-ISOLATED HOSPITALS  
IN THE  
KAHRAMANMARAS EARTHQUAKES OF FEBRUARY 6, 2023**

**AN OBSERVATION REPORT**

**TURKISH ASSOCIATION FOR SEISMIC ISOLATION / TASI  
(Deprem İzolasyon Derneđi / DID )**

**May 10, 2023**

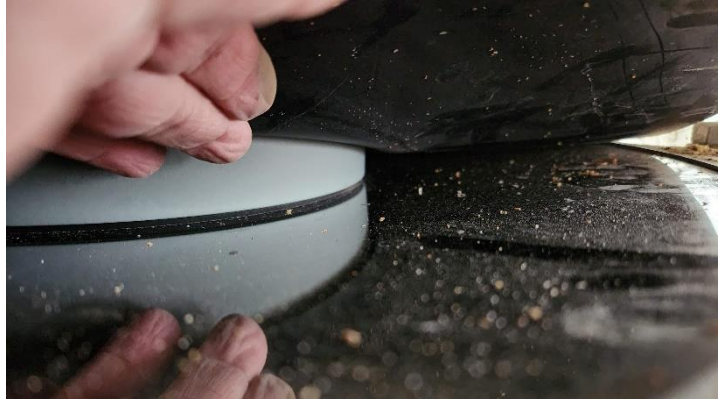
Close-up of isolation bearing slider unit below dust protection skirt

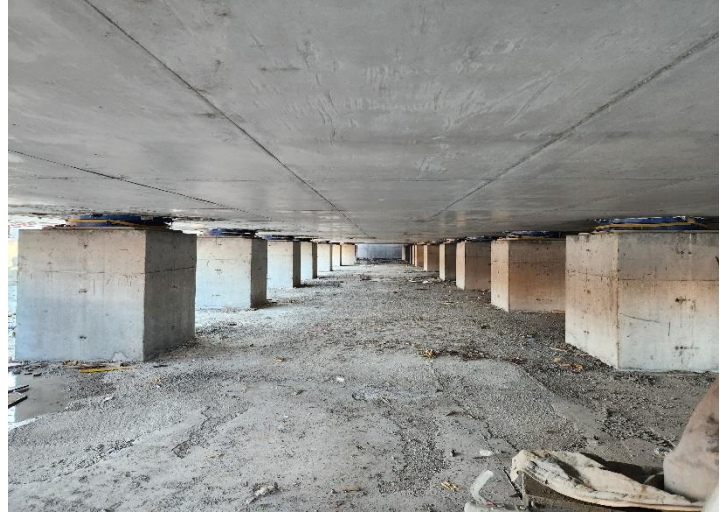
General view of isolation basement

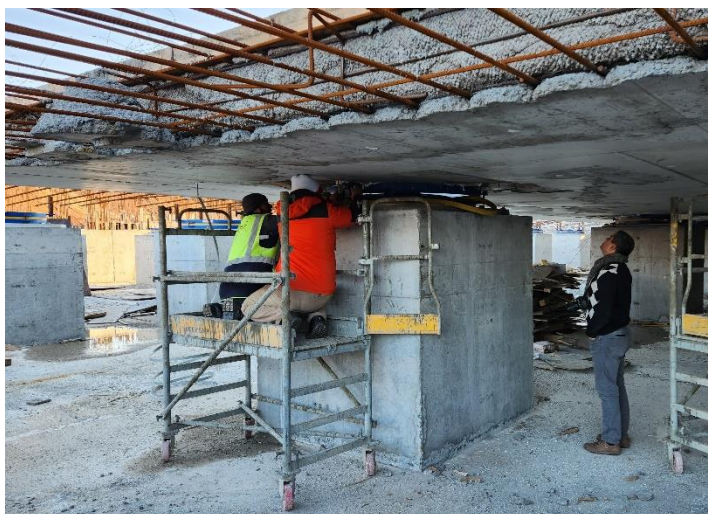
Inspection of isolation bearing with boroscope

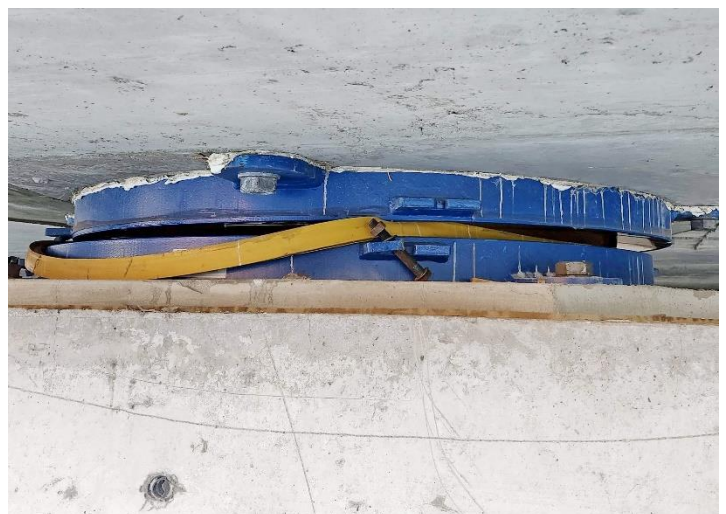
- Hospital under construction at the time of the earthquakes, structurally about 30% complete.
- Isolators had shipping locking bolts attached, which were bent and broken.
- Maximum isolator displacement was approximately 16 cm, and about 4 cm residual offset.

Isolation bearing with offset and disconnected shipping bolts

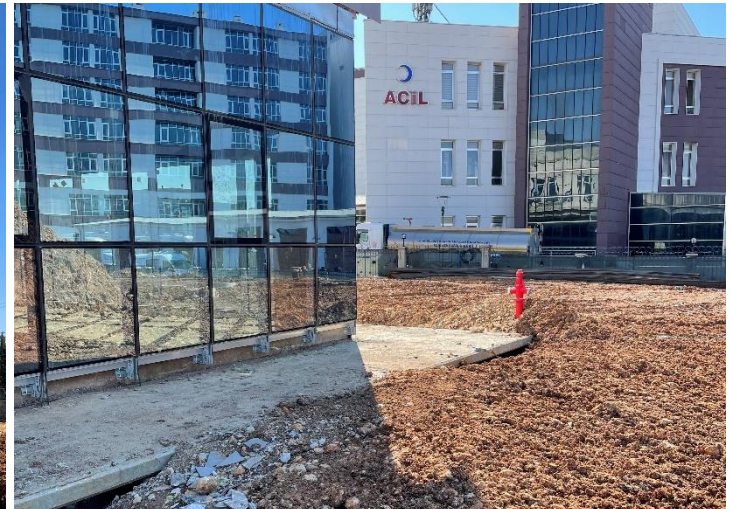
Soil fill at moat cover perimeter

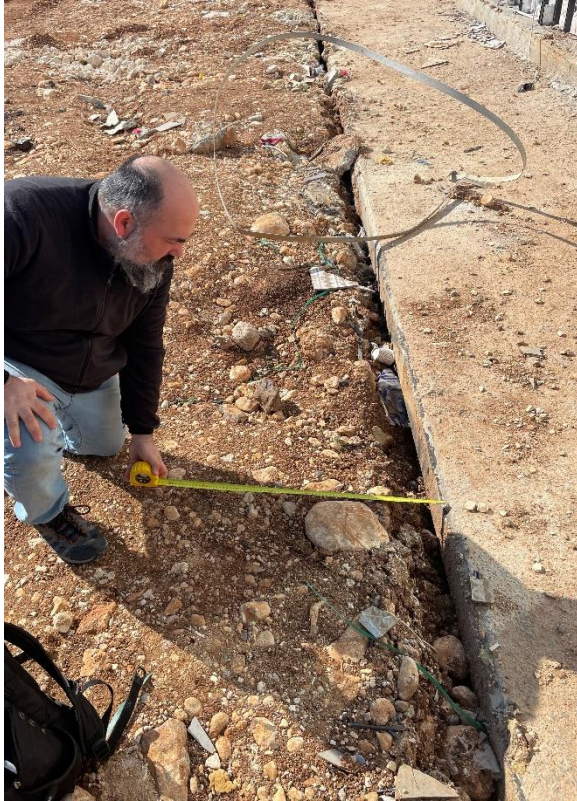
Soil movement at moat cover perimeter

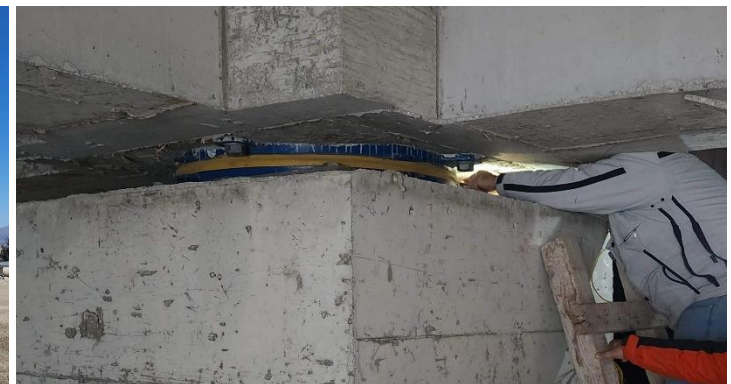
Inspection of isolation bearing using boroscope

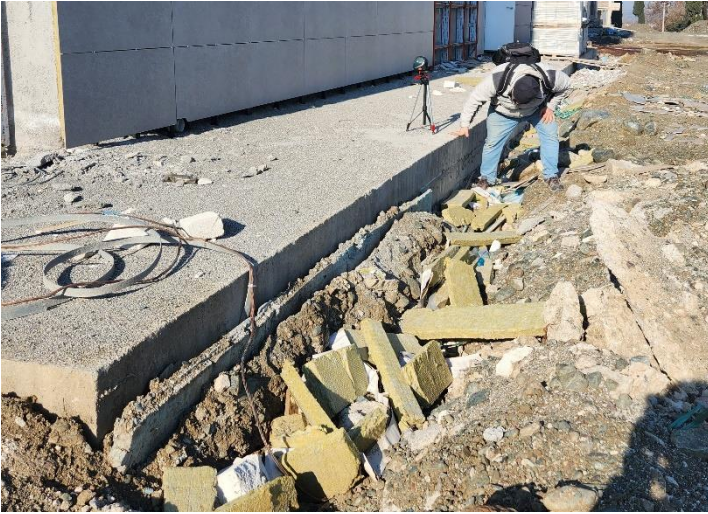
Construction debris and soil at perimeter joint

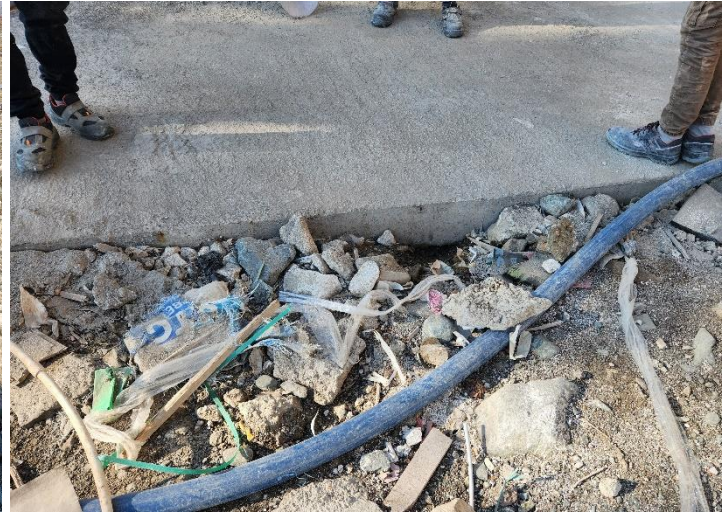
Construction debris restricting movement at moat cover perimeter

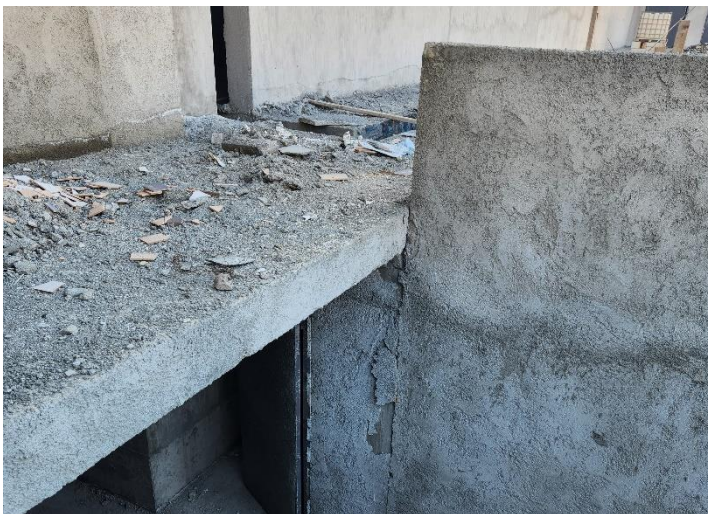
No movement clearance between perimeter moat cover and adjacent wall

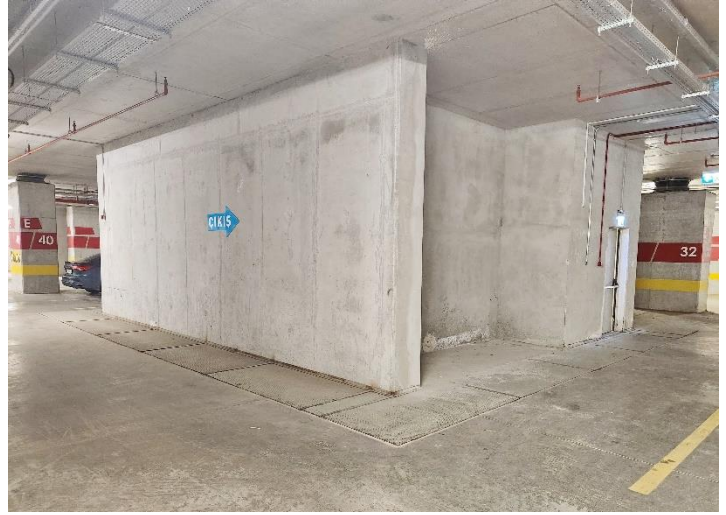
Seismic joint cover around elevator/stairway shaft in basement
