**THE RESPONSE OF SEISMICALLY-ISOLATED HOSPITALS  
IN THE  
KAHRAMANMARAS EARTHQUAKES OF FEBRUARY 6, 2023**

**AN OBSERVATION REPORT**

**TURKISH ASSOCIATION FOR SEISMIC ISOLATION / TASI  
(Deprem İzolasyon Derneđi / DID )**

**May 10, 2023**

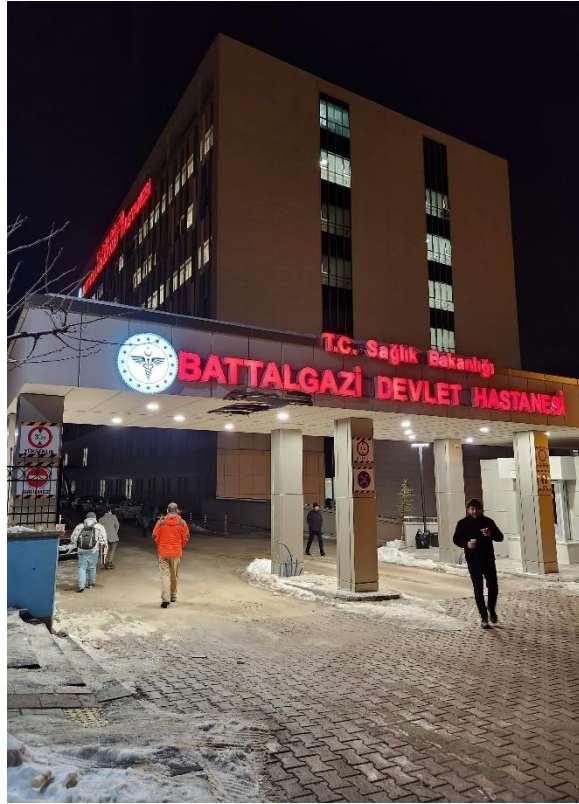
Exterior view of hospital

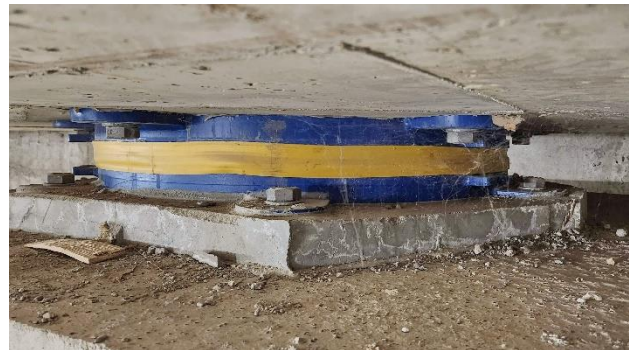
Double pendulum bearing, with small residual offset visible

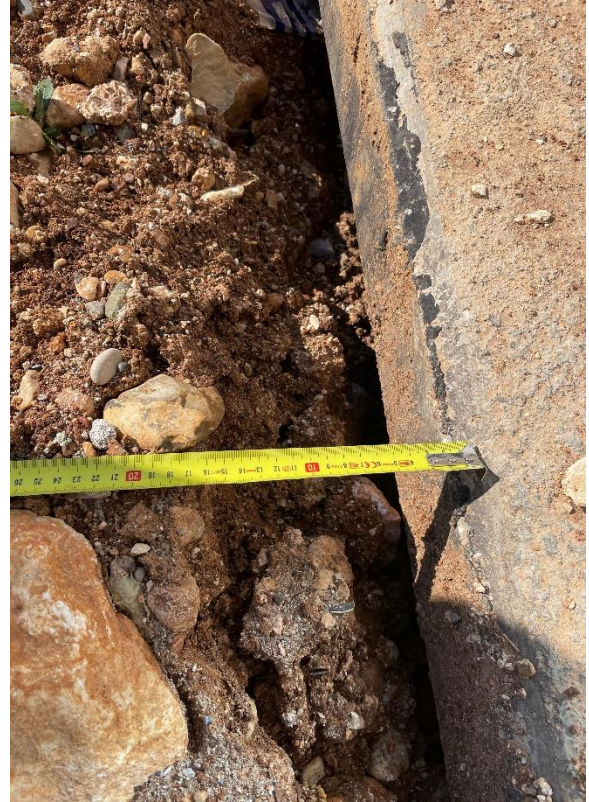
Estimated maximum displacement approximately 12 cm
